# Thermal Imaging for Improving Energy Conservation Behaviors: An Infrared Thermography Survey for Residential Buildings

Husein Ali Husein<sup>1\*</sup>

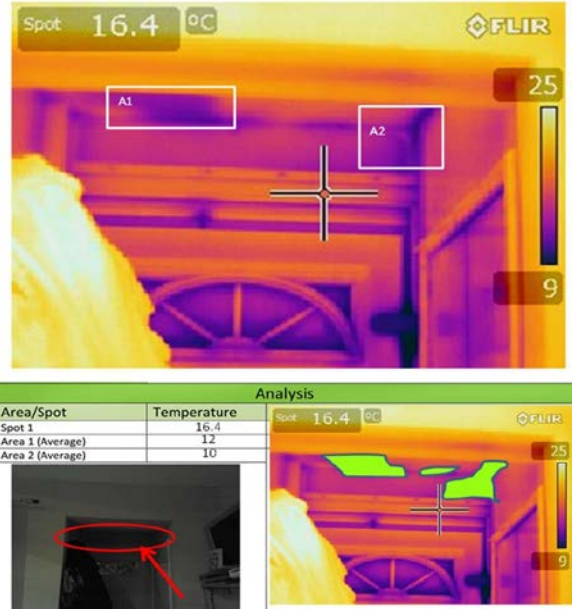
**Figure 6:** Using thermography for the entrance

The green highlighted isotherm in the infrared image shows the area where the surface temperature is below the critical surface temperature which is on average 10°C (Figure 6).

**Area 1** is likely due to the missing /poorly fitted insulation within the pitched roof above the extension.

**Area 2** the junction between the walls shows the cold area which is likely due to missing insulation which allows cold air to infiltrate the residence.

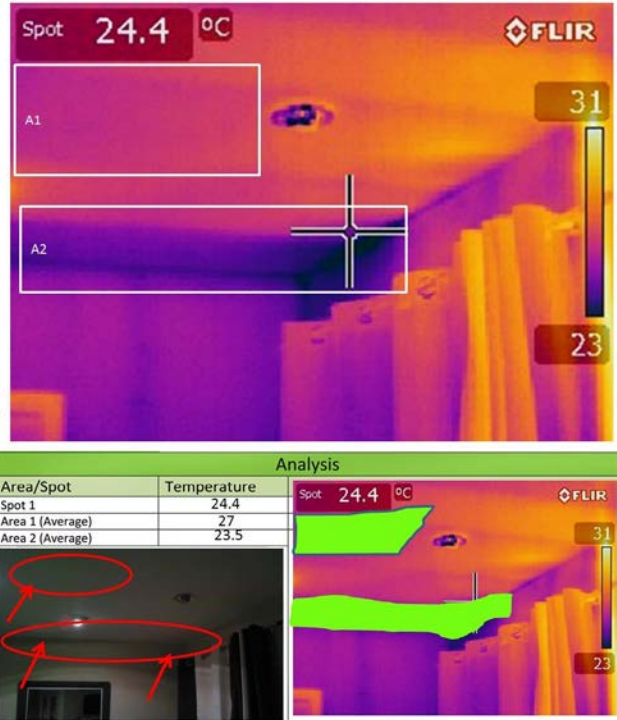
**Figure 7:** Using thermography for the Living room

The green highlighted isotherm in the infrared image (Figure 7) shows the area where the surface temperature is below the critical surface temperature which is on average 23°C. Both area 1 and 2 shows the cold area which is likely due to missing/poorly insulation within the ceiling. The missing insulation and thermal bridging may be a common defect in the new house in the studied area and can also have a significant effect on the energy efficiency of the building fabric. Visual inspection is unlikely to identify defects within the insulation layer once covered over by surface finishes. Therefore, the performance of insulation, which is sensitive to the quality of installation, may be subject to considerable variation. Heat flux measurement and co-heating tests enable thermal transmission to be measured. However, the cost and time taken to conduct these tests are currently a barrier to their more widespread use, particularly during the construction process.

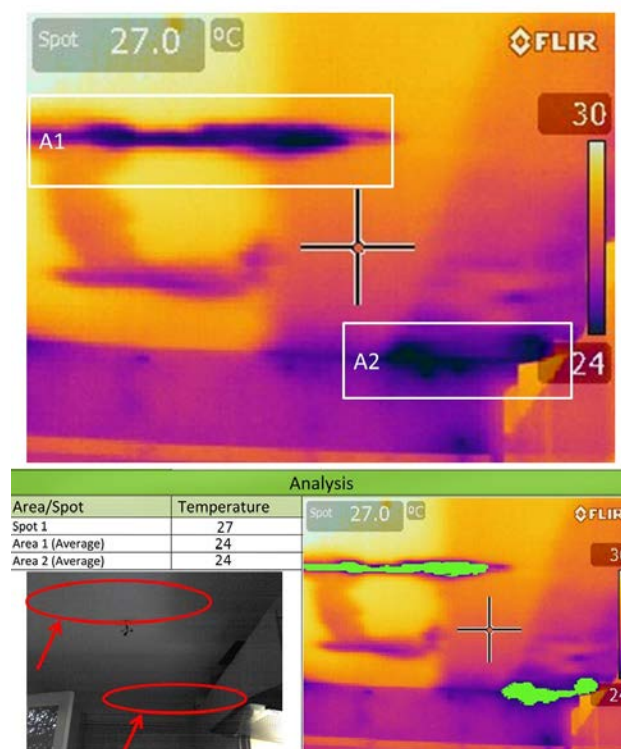
**Figure 8:** Using thermography for the kitchen

The green highlighted isotherm in the infrared image (Figure 8) shows the area where the surface temperature is below the critical surface temperature which is on average 28°C.

- **Area 1:** This image shows a wider area of moisture infection in the ceiling of the kitchen. The big differences in surface temperature that are more than 5°C represent a high degree of water saturation. The dampness in the ceiling is likely due to the water incursion from the leaking pipes that are related to the bathroom on the first floor directly above the kitchen. The concerns of dampness are because it is a source that supports the growth of bacteria, fungi, and insects.
- **Area2:** The highlighted joint between the wall and ceiling seems to be affected by two sources, air leakage from external and water leaking from the bath floor. This is likely due to the missing insulation in the ceiling and poor insulation in the external wall.

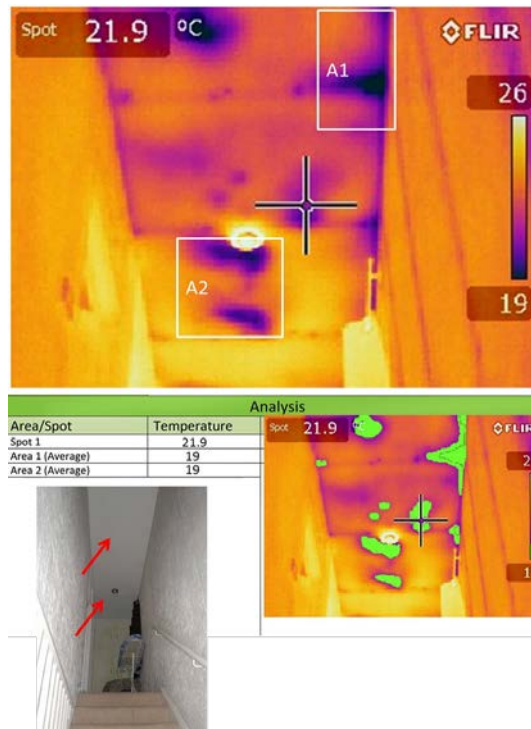
**Figure 9:** Using thermography for the staircase area

The green highlighted isotherm in the infrared image shows the area where the surface temperature is below the critical surface temperature which is on average 19°C.

These areas illustrate the dampness in the ceiling due to the missing insulation also it shows the cold air infiltration which leads to heat loss and eventually reduces the efficiency of the building.

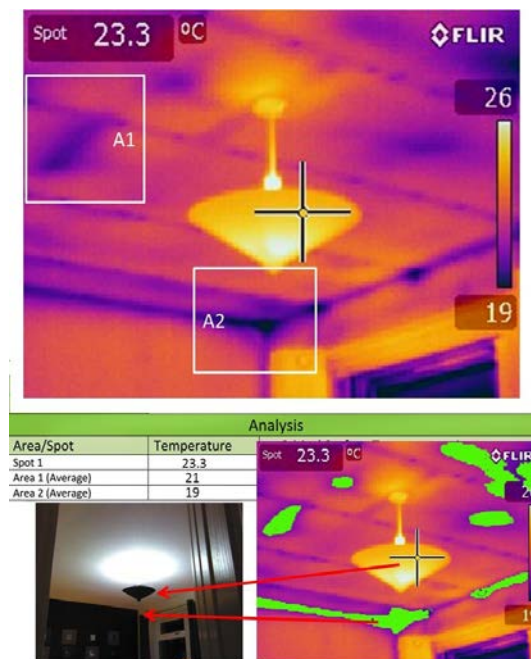
**Figure 10:** Using thermography for the bedroom

The dark blue areas (Figure 10) in the ceiling represent the area where the temperature of the surface is below the critical surface temperature which is on average 23.3°C

**Area1:** These wide spots in the ceiling show the missing of the fitted insulation in the loft.

The missing insulation leads to an increase the air infiltration from and into the room, which has an impact on reducing the heating efficiency in the room due to a large amount of air penetrating the ceiling, especially on windy days.

However, area 2 shows the joint poor/missing insulation which causes air leakage.

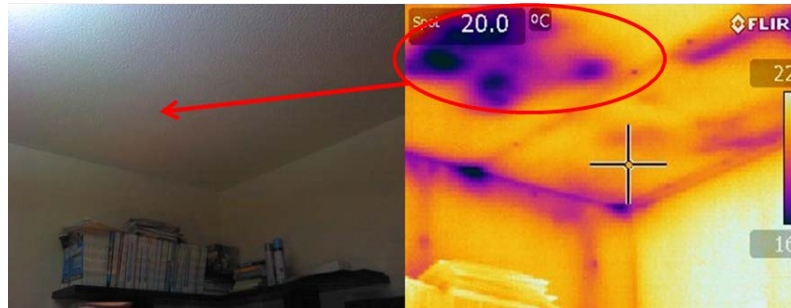
**Figure 11:** Wide spot of air infiltration due to missing fitted insulation in the loft

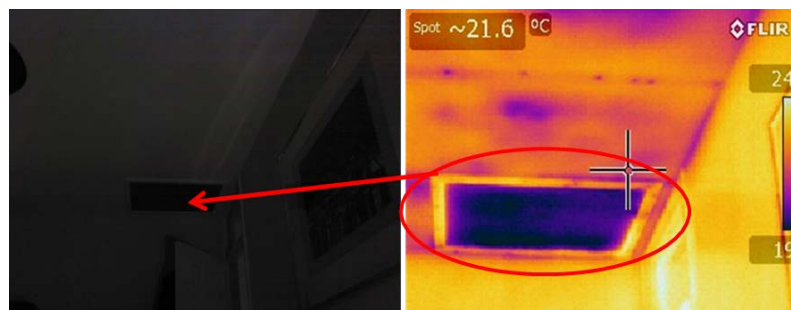
**Figure 12:** The small opening to the loft level creates a thermal bridge

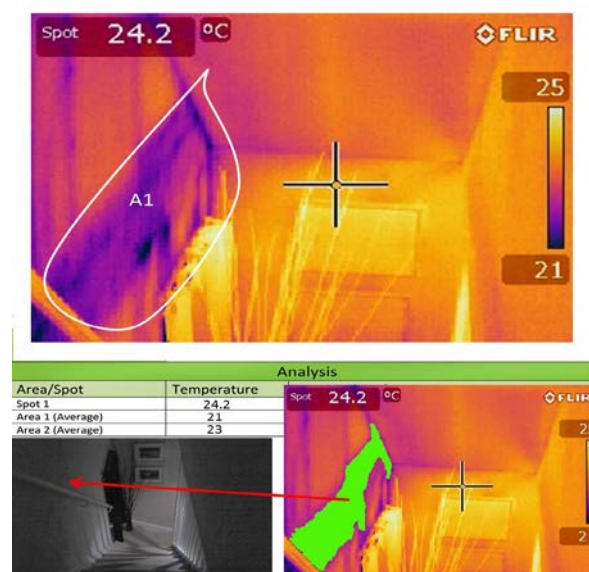
**Figure 13:** the defects on the staircase wall

The green highlighted isotherm in the infrared image (Figure 13) shows the area where the surface temperature is below critical surface temperature which is on average 24°C.

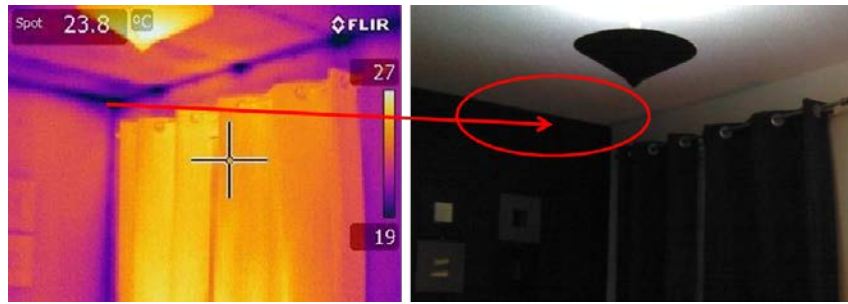
**Figure 14:** Investigations in the bedroom wall

The dark blue area in the wall (Figure 14) is due to cold air infiltration from the ceiling joint and this is due to poor/missing insulation.

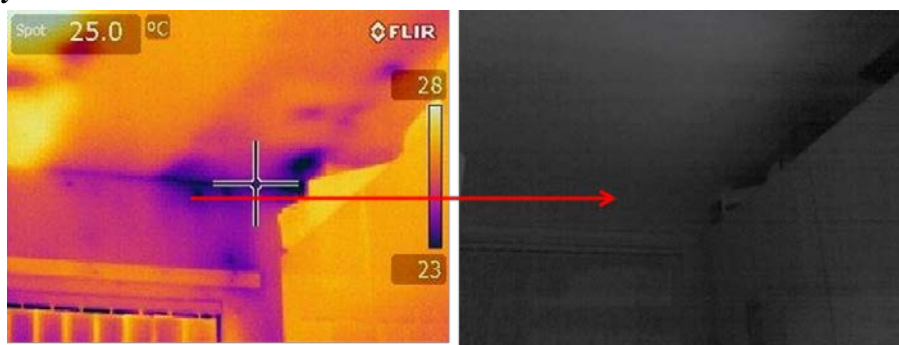
**Figure 15:** Kitchen wall under thermography

Water leakage and also air infiltration lead to heat loss through the cold area shown in the image due to poor/missing insulation.

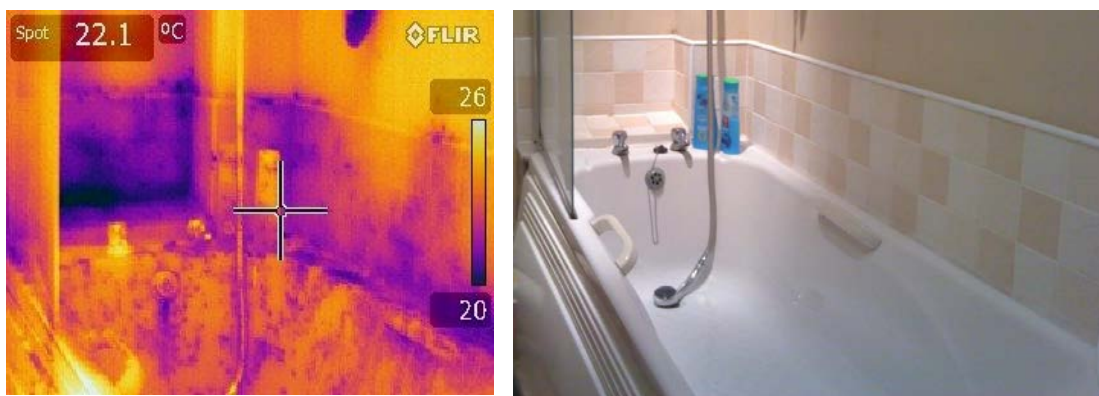
**Figure 16:** leakage of the water in the side of the bathroom

The image (Figure 16) illustrates the leakage of water into the side of the bathroom. This is due to poor insulation being used for the bath.

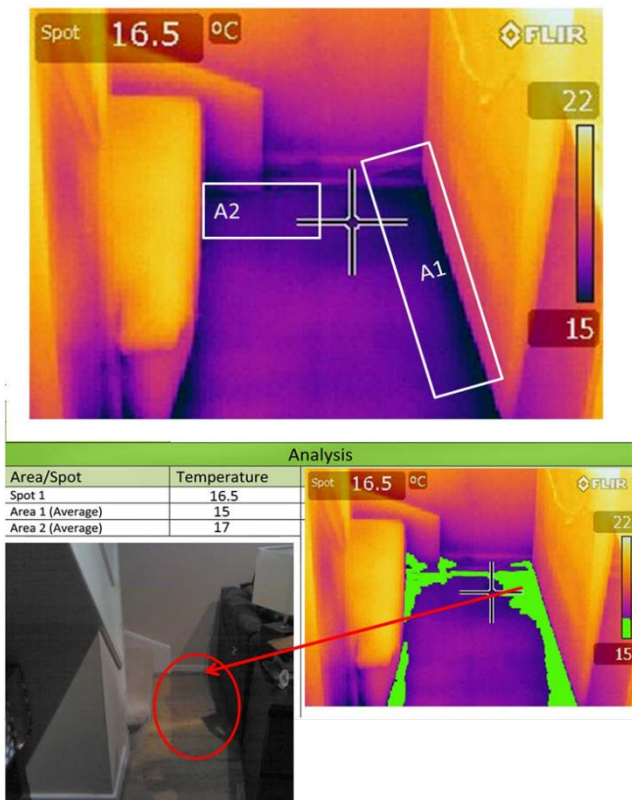
Figure 17: Living room floor under thermography

The green highlighted isotherm in the infrared image shows the area where the surface temperature is below the critical surface temperature which is on average 22°C (Figure 17), and which is on average 20°C (Figure 18).

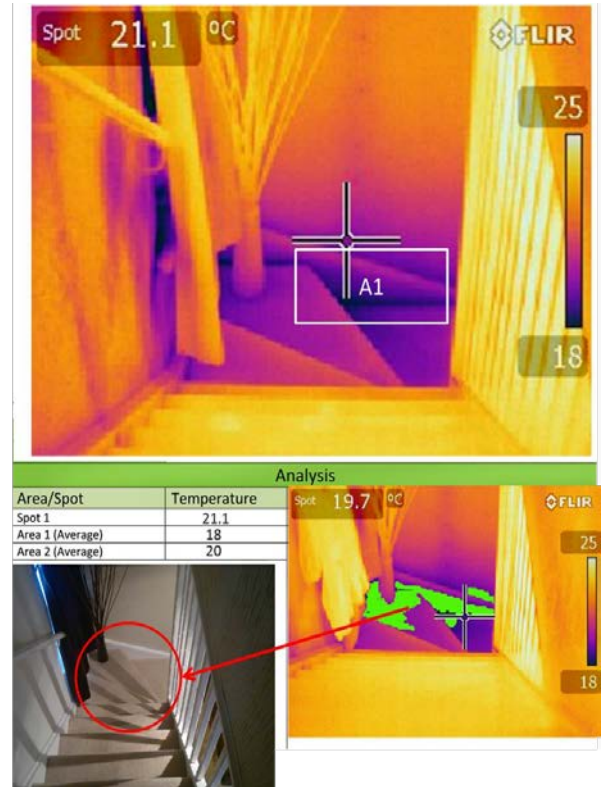
Figure 18: Analysis of staircase walls

The large difference between the floor temperature and another surrounding surface (Figure 18) which is around 7°C illustrates a cold area where the heat is lost; this is likely due to missing insulation.

This cold area causes air leakage and also heat loss (Figure 18) this is likely due to the thermal bridge having been made by the winder and missing the insulation.

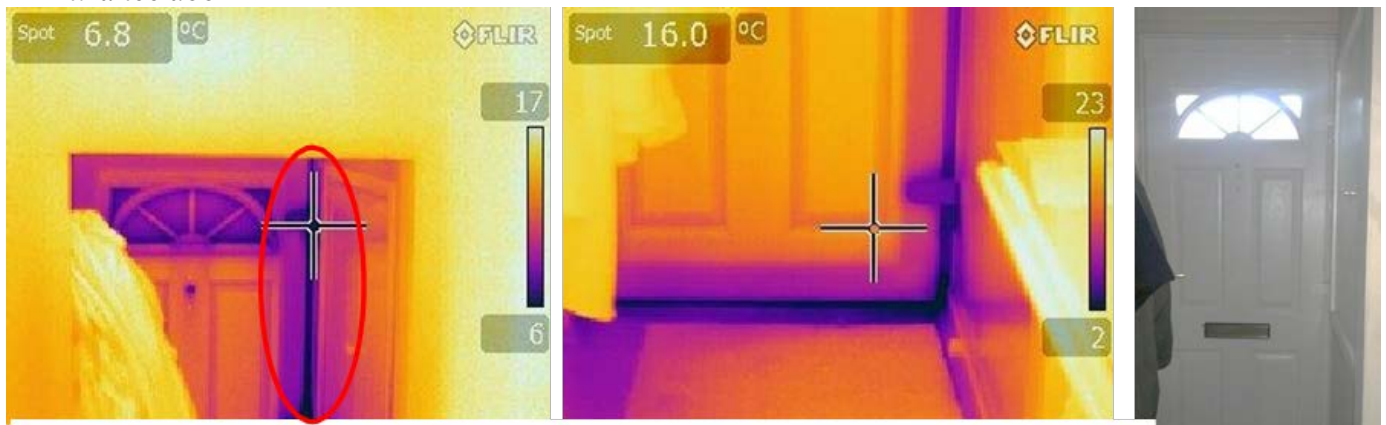
Figure 19: Investigation of entrance door under thermography

The black area (Figure 19) represents the area where the cold area is due to air infiltration, this is related to the defective seals on the top and bottom of the door profile.

By comparing these varying temperatures around the image, it is possible to identify cold air ingress in between the doors, and infer that by weatherproofing, comfort in that part of the home can be improved and energy costs reduced.

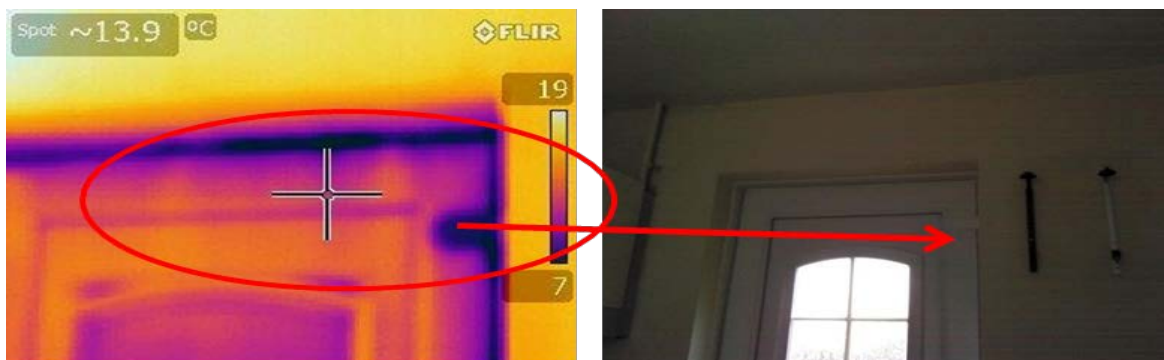
**Figure 20:** Defective seals on the top of the door profile

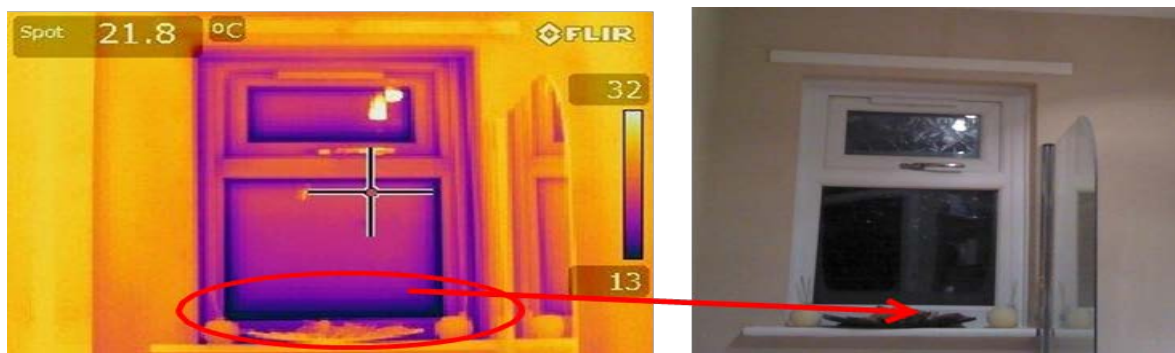
**Figure 21:** Detections around windows at the bottom.

The highlighted area (Figure 21) is cold air with a temperature of less than 14°C. This is likely due to the defective seals around the window frame and opening, allowing cold air to enter the house.

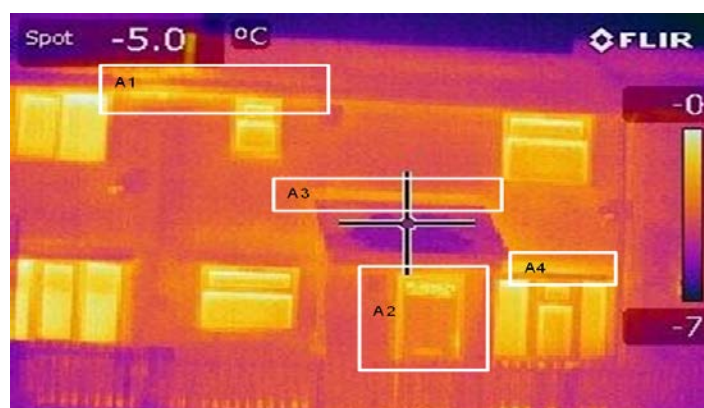
**Figure 22:** Thermography photo of the elevation walls.

**Area 1** shows a comparative increase in surface temperature, due to missing/poorly fitted loft insulation at the eaves of the roof.

**Area 2** is showing an increase in surface temperature around the door frames, possibly due to defective seals around the window openings allowing warm air to escape.

**Area 3** is showing an increase in the temperature above and around the extension area and this is due to poor/ missing insulation in the joints which leads to heat loss.

**Area 4** shows a comparative increase in surface temperature which is likely due to the window lintels creating a thermal bridge.

The temperatures of the windows appear to vary as well. Consider area 6, which looks to be cooler than area 5. Given that the two windows are in the same room and have the same temperature, the variation in infrared radiation is caused by infrared reflection from buildings on the opposite side of the road. They primarily measure infrared radiation, and various factors such as humidity, distance from the item, object emissivity, and reflection of infrared radiation from other sources can all influence the findings.
