## Anastylosis with Technical Analysis of the Restoration of Phimai Historical Park in Thailand

Worrawit Boonthai<sup>1</sup>, Bhatraradej Witchayangkoon<sup>2\*</sup>, Yasser Arab<sup>3\*</sup>, Ahmad Sanusi Hassan<sup>4</sup>

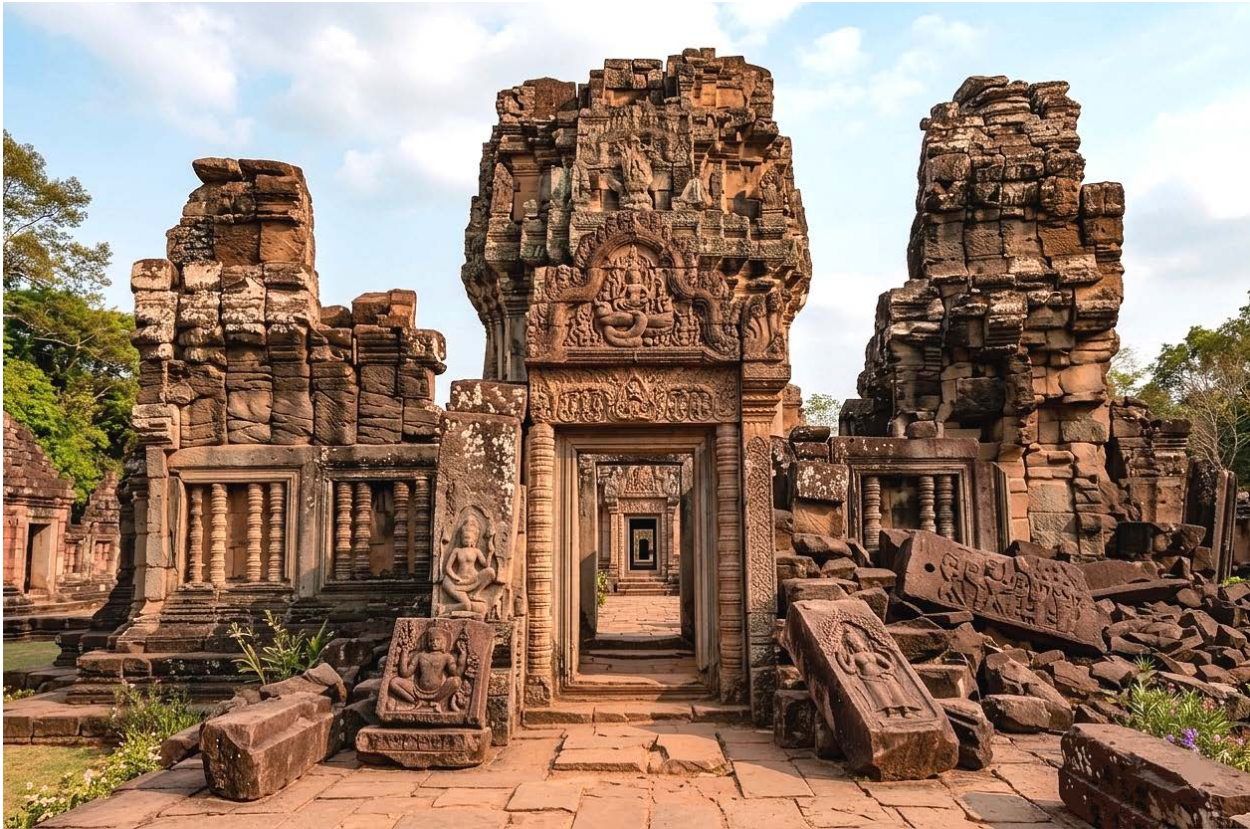
**Figure 2:** The ruined PHP before the restoration. (digitally remastered image).

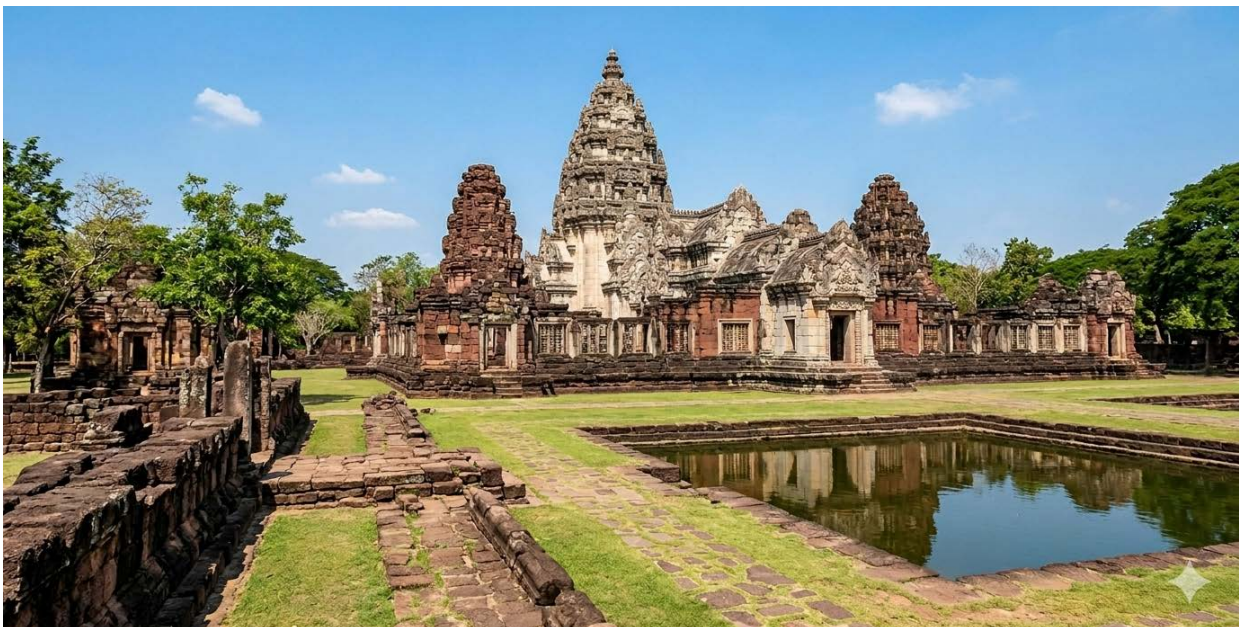
Figure 3: Current Phimai Historical Park (PHP) (Prasat Hin Phimai)
