# Thermal Imaging for Improving Energy Conservation Behaviors: An Infrared Thermography Survey for Residential Buildings

Husein Ali Husein<sup>1\*</sup>

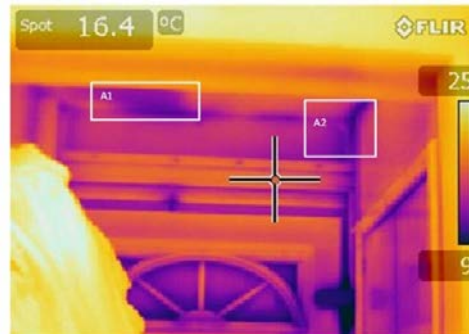
building. Smoke generators may be used to identify significant areas of leakage in the building or a portable smoke “pencil” can identify leakage in specific locations. Leakage generates thermal abnormalities with more irregular shapes than insulation inadequacies and with considerable temperature variations, frequently generating distinctive streaks or rays patterns. In Figure 1, the air leakage above the balcony door cools the surface of the surrounding wall and ceiling.

**Figure 1:** The air leakage defects

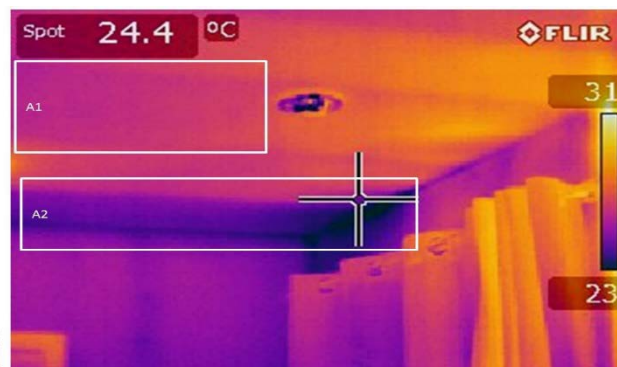
**Figure 2:** Missing insulation defects
